Cladding Deflection Evaluation for Wayne Building Products Lux Panel

Cladding Deflection Evaluation for Wayne Building Products Lux Panel Final Client Report

Report No: A1-008208-01.1
Report Date: 11 March 2016
Contract No: A1-008208-01
Agreement date: 11 January 2016
Program: Building Regulations for Market Access

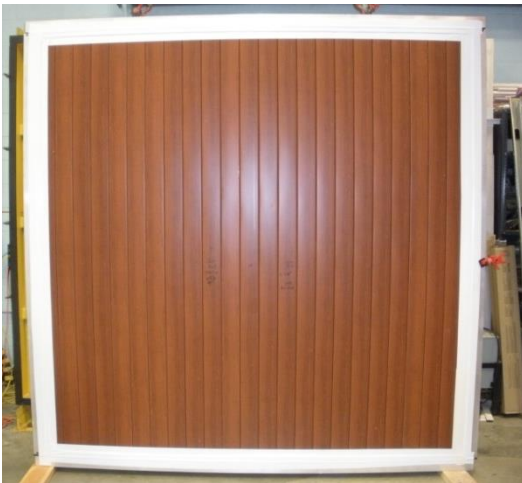
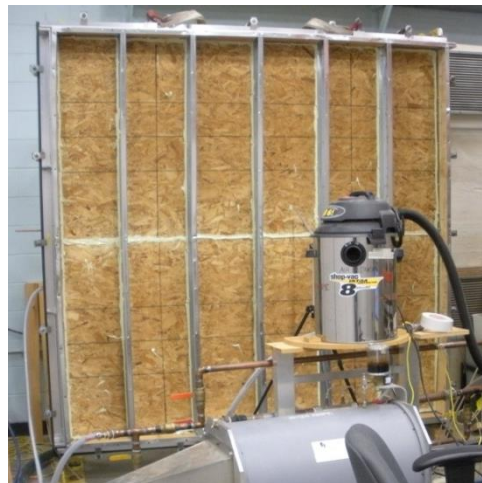
The specimen used in the evaluation was constructed by the client and shipped to NRC; it was received on January 5, 2016. It measured 2.44m by 2.44m (8-ft. x 8-ft.) and consisted of non-load bearing steel studs spaced at 400 mm (16-in.) on center, with OSB as the sheathing board. The OSB sheathing was butt jointed at the vertical centre of the wall (1.22 m, 4-ft.). The specimen is shown in Figure 1.

Figure 1: Photos of cladding deflection test specimen showing exterior (left) and interior (right)

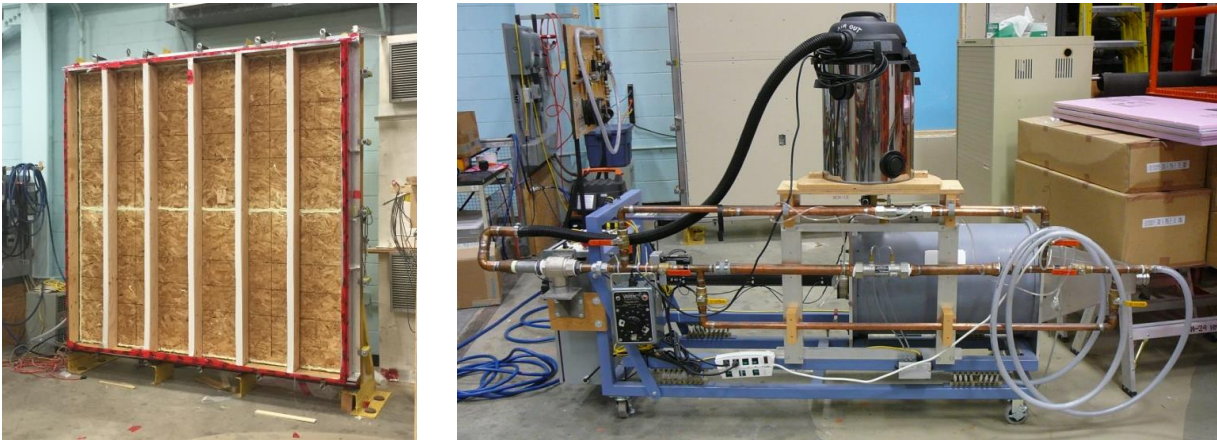
The NRC Wind load apparatus (Figure 2) consists of a steel chamber to which a 2.44 m x 2.44 m (8-ft. x 8-ft.) specimen is installed. A pressure actuator is used to impart the desired static and dynamic pressures to the test chamber and across the test specimen. The actuator and chamber are capable of supplying static and dynamic loads up to $\pm 3\text{kPa}$.

Figure 2: NRC Wind Load Aging apparatus – chamber (left) and actuator (right).

The conditioning protocol is discussed in section 1.4 of the *Wind Load Cladding Deflection Protocol*. The pressure acting on the cladding and deflections arising from the loads was monitored during testing and stored in a data acquisition system (DAQ) affixed to the actuator.

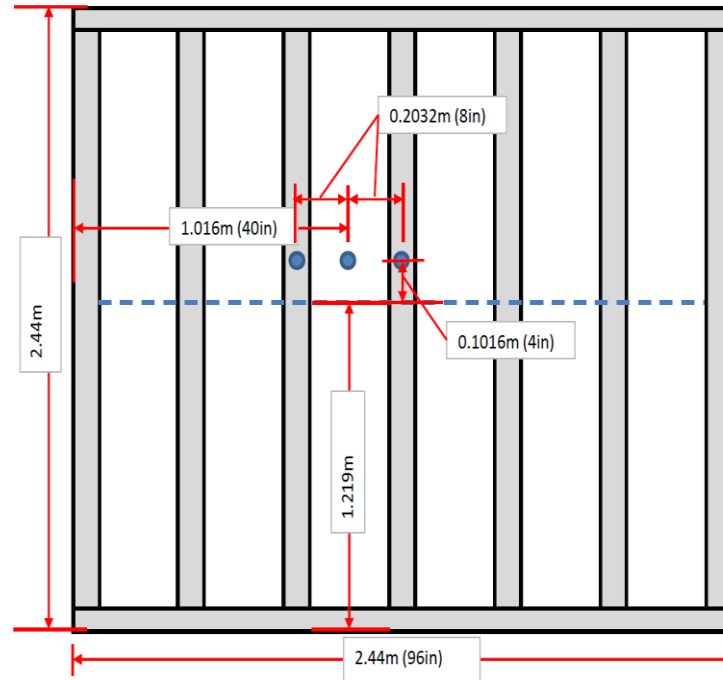
As shown in Figure 3, the cladding deflections were measured in the centre of the cladding profile located in the centre of the stud cavity, and at the closest corresponding right and left stud location to the centre stud cavity cladding location. Due to the horizontal joint in the sheathing board, cladding deflections were measured at 101.6 mm (4-in.) above the joint. The deflection of the sheathing board at the center of the cladding profile, and deflections of the steel stud to the right and left of the center cladding profile were measured. To ensure that the maximum deflections for the test specimen (cladding, sheathing board, and studs) were captured during the test, locations for taking deflection measurements were selected as those farthest from the perimeter where the specimen was attached to the rigid test chamber.

Figure 3: Displacement sensor locations.

Cladding deflection — The cladding deflection was monitored using a laser distance measuring device (*Keyence LD-70*), accurate to $\pm 0.01\text{ mm}$. The stud deflection and sheathing board deflection were measured using linear potentiometers (*Penny and Giles HLP190*) also accurate to $\pm 0.01\text{ mm}$.

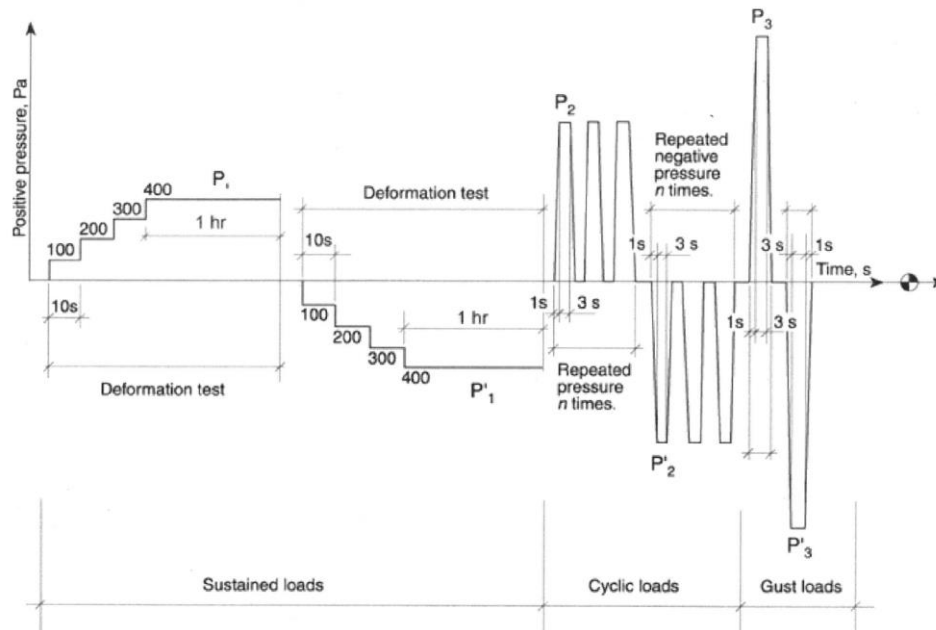
The wind load cladding deflection test protocol was conducted in accordance with ASTM E330 Procedure B¹ to wind loads calculated from information provided by the client (Appendix A) and load tables provided in the § on the Wind Load Resistance protocol of the *CCMC Technical Guide*². The wind load aging protocol as well as the pressure levels tested are described in Figure 4 and Table 1. To be considered a pass, the cladding must be capable of resisting the positive and negative forces generated by the design wind loads without any fracture or permanent deterioration of the surfaces resulting from such design loads.

Figure 4: Wind Load Profile

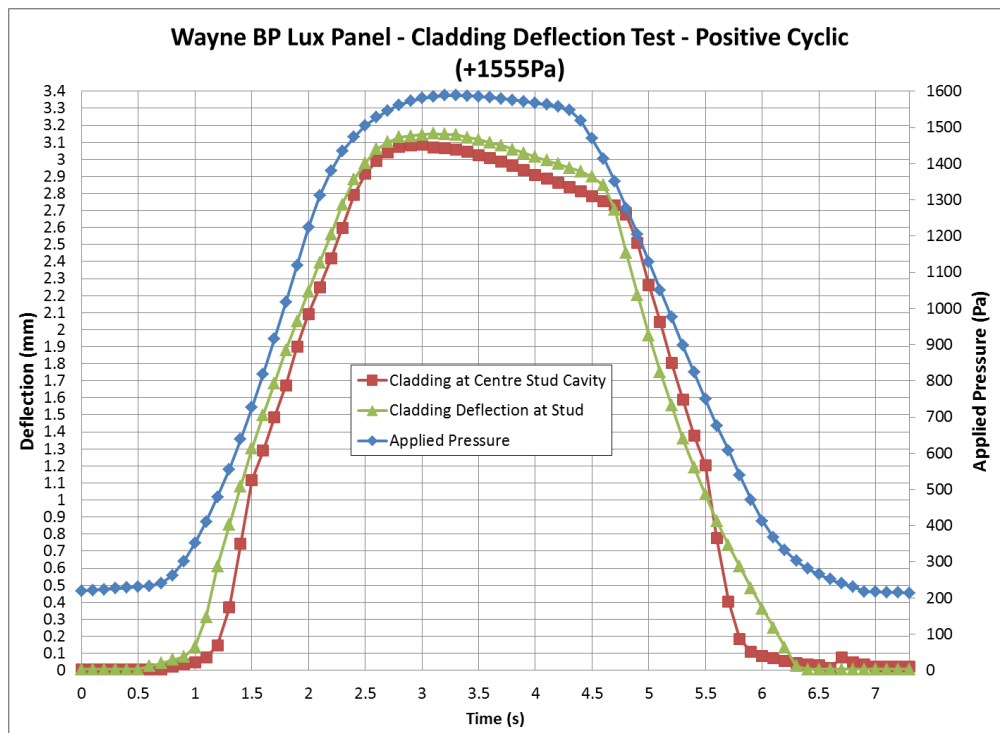
The loading profile for the Phase 2 (Cyclic) load profiles is shown in Figures 5 and 6. These figures show the profiles of the net cladding deflection during an average positive and negative cycle. The deflection profile was determined from data gathered during numerous snapshots during the cycle. The maximum deflection measured during these cycles is presented in Table 3.

**Figure 5: Representative cladding deflection test results during the positive cyclic applied pressure.**

Pressure (Pa)	Cladding at Centre Cavity Deflection (mm)	Cladding at Stud Deflection (mm)
1588	3.09	3.15
-1556	-3.12	-2.93
2432	4.70	4.46
-2326	-3.13	-3.95

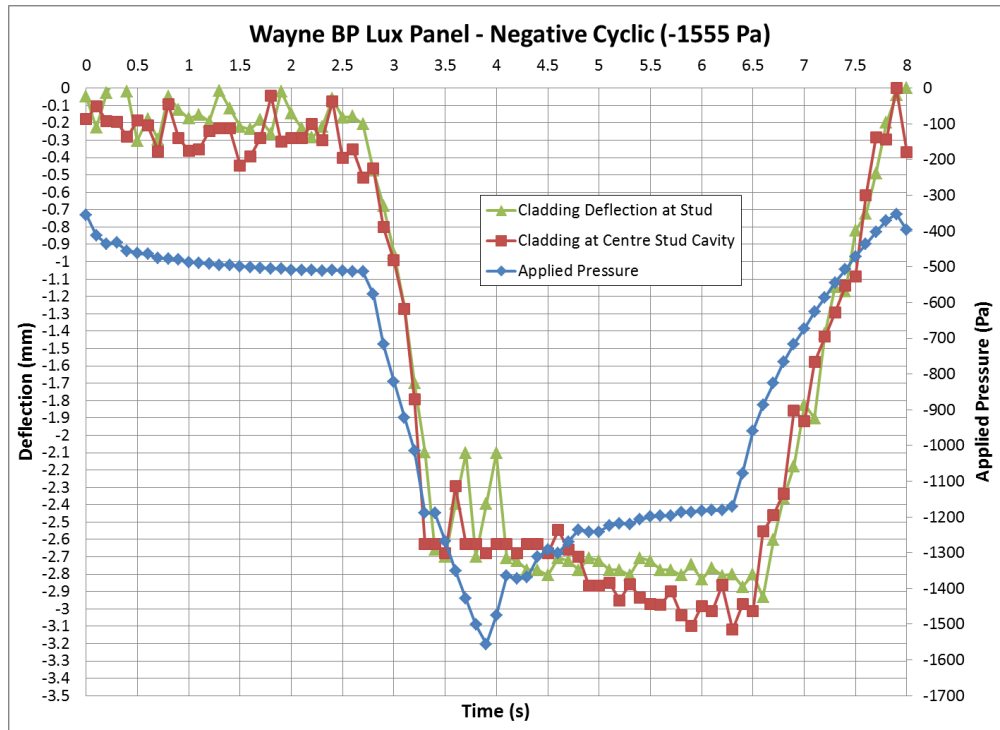
Figure 6: Representative cladding deflection test results during the negative cyclic applied pressure.

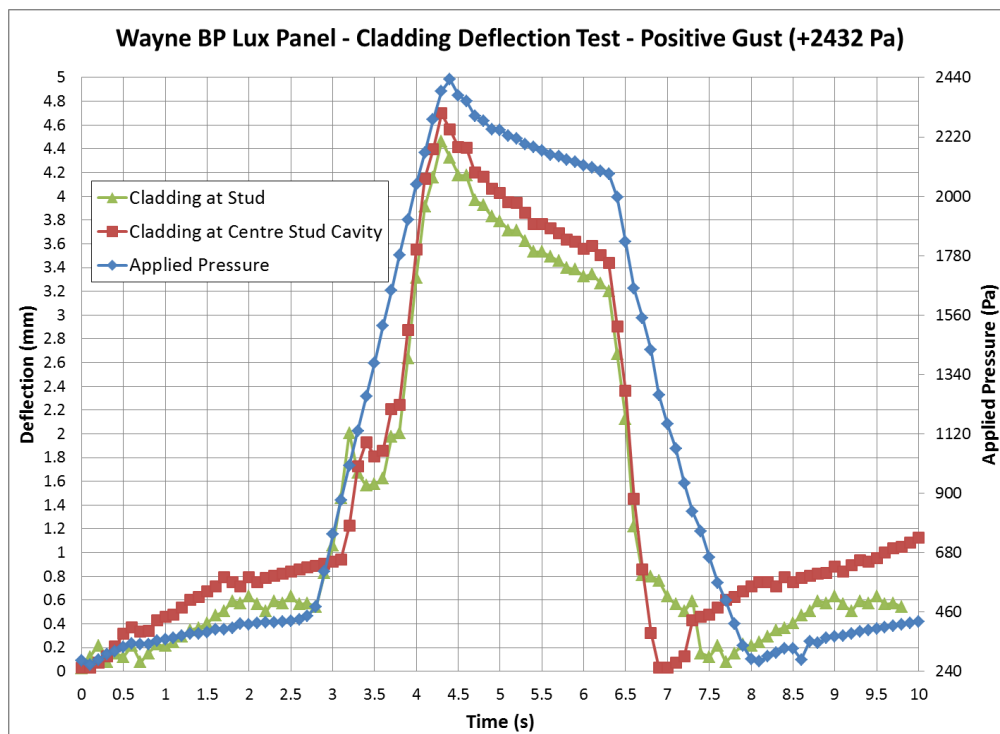
Cladding deflection profile during the Phase III loading protocol is shown in Figure 7 and 8 for the positive and negative loading protocols. The maximum deflection during the test is given in Table 3.

Figure 7: Representative cladding deflection profile during a positive gust loading

As provided in Table 3, a maximum cladding deflection of 4.7mm was measured during the positive gust cycle of +2432 Pa.

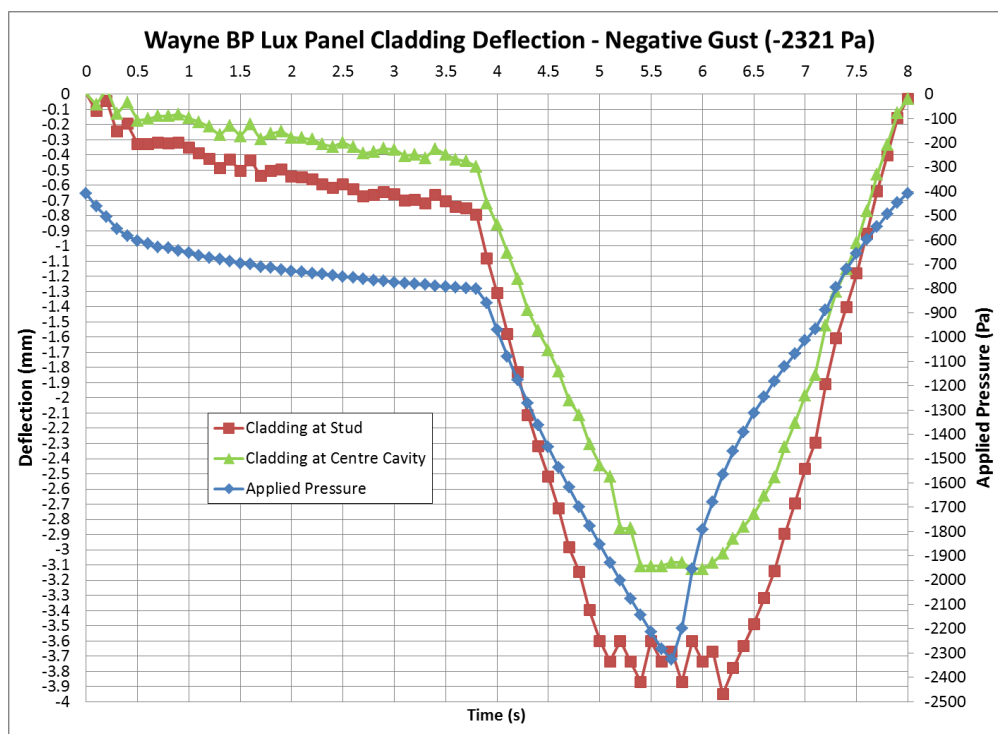
Figure 8: Representative cladding deflection profile during a negative gust loading

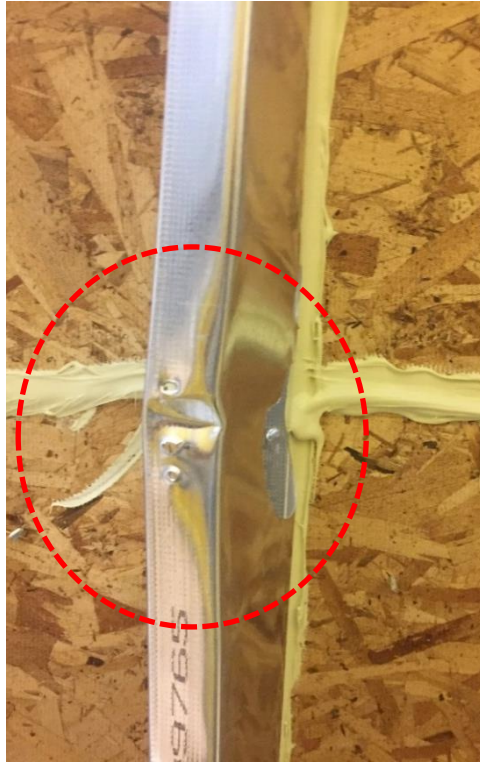
During the portion of the test where negative cyclic loads acted on the test specimen, the steel studs on one side of the specimen buckled in their center height at approximately -800 Pa pressure. To complete the cladding deflection test, these studs were thereafter reinforced with plywood horizontal strapping. As the purpose of this evaluation was determining cladding deflection under loads, and not deflections of the test specimen, no assumptions are made regarding the performance of this wall configuration under field loading conditions. However, care should be taken to ensure that the steel stud gauge is properly selected for the expected wind loads in a full scale wall design. Photos of the buckled steel studs and plywood strapping that were used in the test are shown in Appendix B. Through visual observation the buckled studs did not have any effect on the cladding.

Figure 9: Photo of one buckled stud. This occurred during the negative cycling at approximately -800Pa.

Care should be taken when using this wall configuration in the field to ensure that the stud gauges are properly sized for the intended use.

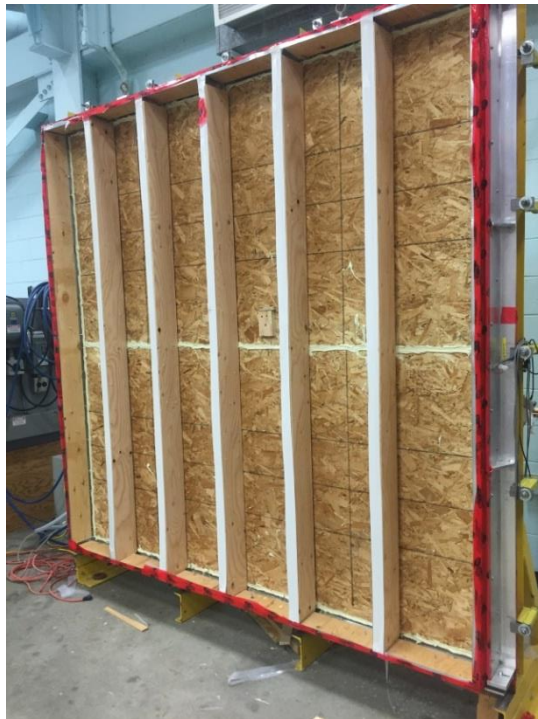
Figure 10: The buckled studs were straightened and reinforced with 3/4in plywood strapping so that the cladding deflection tests could be completed.

locations. Visual and measurement results of the cladding after testing showed that no permanent deterioration or fracture of the cladding occurred during testing. The measured deflection results showed that the maximum cladding deflection during testing was 4.70mm. It should be noted that although the cladding suffered no permanent deflection or visually apparent degradation during testing, this was not the case for the steel studs. During negative load testing the steel studs on one side of the specimen buckled at their center, and subsequently required support of horizontal plywood strapping to complete the cladding deflection testing.
